NDRRMC UPDATE

SitRep No. **02** re Magnitude 6.6 Earthquake in Cataingan, Masbate

DATE: 20 August 2020

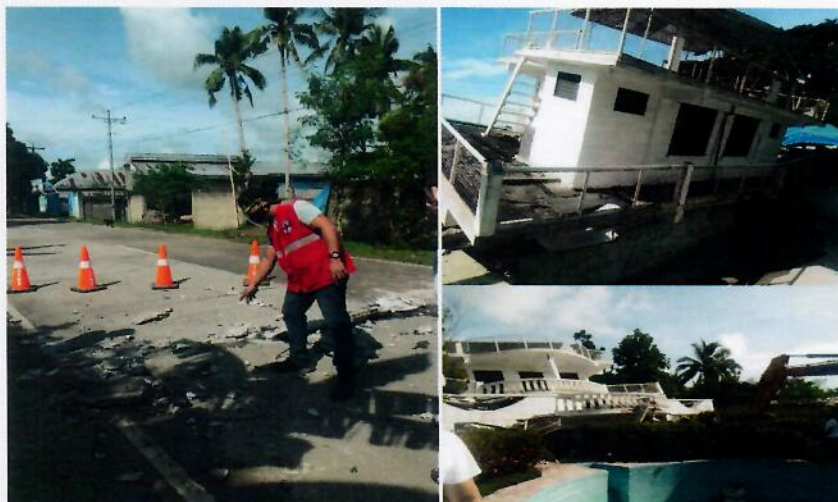
Source: Philippine Information Agency, Region V

REGION/PROVINCE/ MUNICIPALITY/CITY	INFRASTRUCTURE	REMARKS
REGION V		
Masbate		
Cataingan	Cataingan Astrodome and Municipal College	101 LSIs quarantined were relocated due to visible cracks in the facility.
	Cataingan District Hospital	Patients were evacuated outside the facility.
	Concrete road and docking area of Cataingan Port	-
	Public Attorney's Office Building	-
	Old and New Cataingan Public Market	-
	Cataingan Municipal Police Station	-
Dimasalang	DPWH Masbate 3rd DEO Building	Damages on walls, partitions, tiles, and glass door
	Dimasalang Port	Damaged concrete pavement
Palanas	Palanas Police Station Building	Damaged on columns, walls, and partitions
REGION VIII		
Samar	McDonald's, Gaisano Grand Mall, Calbayog City	Glass Panel

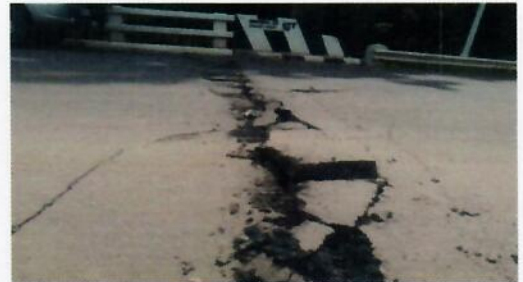
Source: DPWH

A total of **six (6) road sections and seven (7) bridges** in the **Provinces of Masbate and Camarines Sur** were reported damaged due to the incident. Warning signs were installed to inform motorists. As of 18 August 2020, **all roads and bridges were declared passable.**
